DEPARTMENT OF TRANSPORT

**INFORMATION CIRCULARS TO  
AIR ENGINEERS AND AIRCRAFT OWNERS**

1928-1939

### INFORMATION CIRCULARS TO AIR ENGINEERS AND AIRCRAFT OWNERS

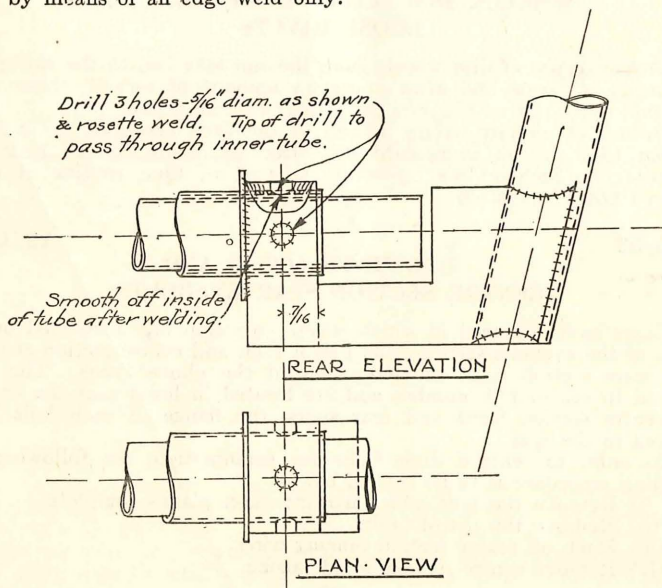
The cranked fitting at the bottom of the right hand pilot's right rudder pedal lever secures the tube connecting to the other pilot's corresponding lever by means of an edge weld only.

Owners are advised to inspect this connection carefully and if there are any signs of failure, the joint should be repaired and reinforced by the addition of three rosette welds as illustrated below.

This reinforcement is to be embodied in any case before the next renewal of Certificate of Airworthiness.
